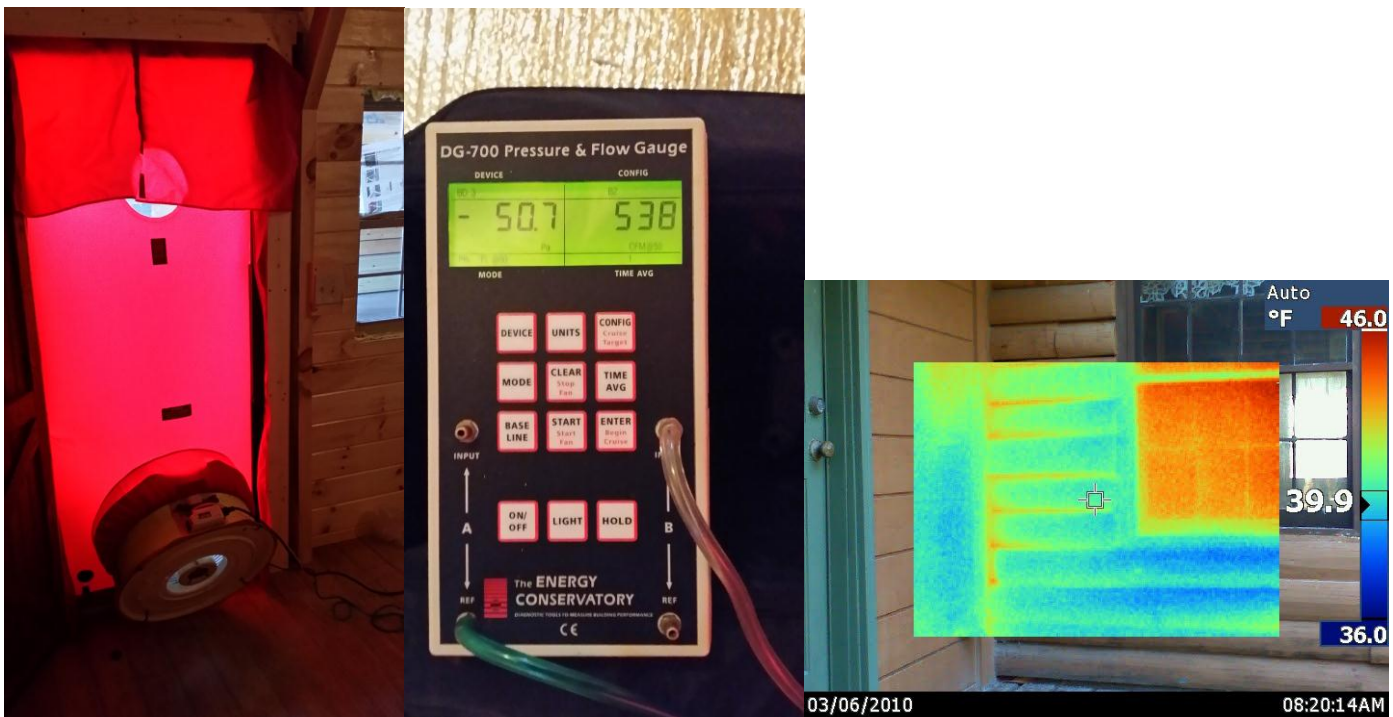
We recently had a BPI (Building Performance Institute, www.bpi.org)-certified energy auditor test our insulated cabins with a blower door and thermal imaging camera, to find any air leaks. He stated: "The cabin is very well built and by air tightness standards the IR (infiltration rate) is around 100 CFM (cubic feet per minute) above the BAS (building airflow standard), which is the minimum amount of fresh air required. Any additional air sealing should be done with caution." Translation- these cabins are very air tight, with their hybrid insulated energy efficient design. Leaky homes are hard to heat and hard to cool. The only way to know whether a home is leaky or tight is to measure its air leakage rate with a blower door. A blower door is a tool that depressurizes a house; this depressurization exaggerates the home's air leaks, making the leaks easier to measure and locate. An energy-efficient house must be as airtight as possible. Every house leaks, and that's why blower-door tests are used — to measure a building's leakage rate. A thermal imaging camera sees specific areas with low airsealing-sample picture (not actual results) attached. See <http://www.greenbuildingadvisor.com/blogs/dept/musings/blower-door-basics> for more blower door info.
